HTC Reference: Q3000

Report Issued: 2nd October, 2018

Flow and Pressure Test Report for 655 Toohey Road, Salisbury

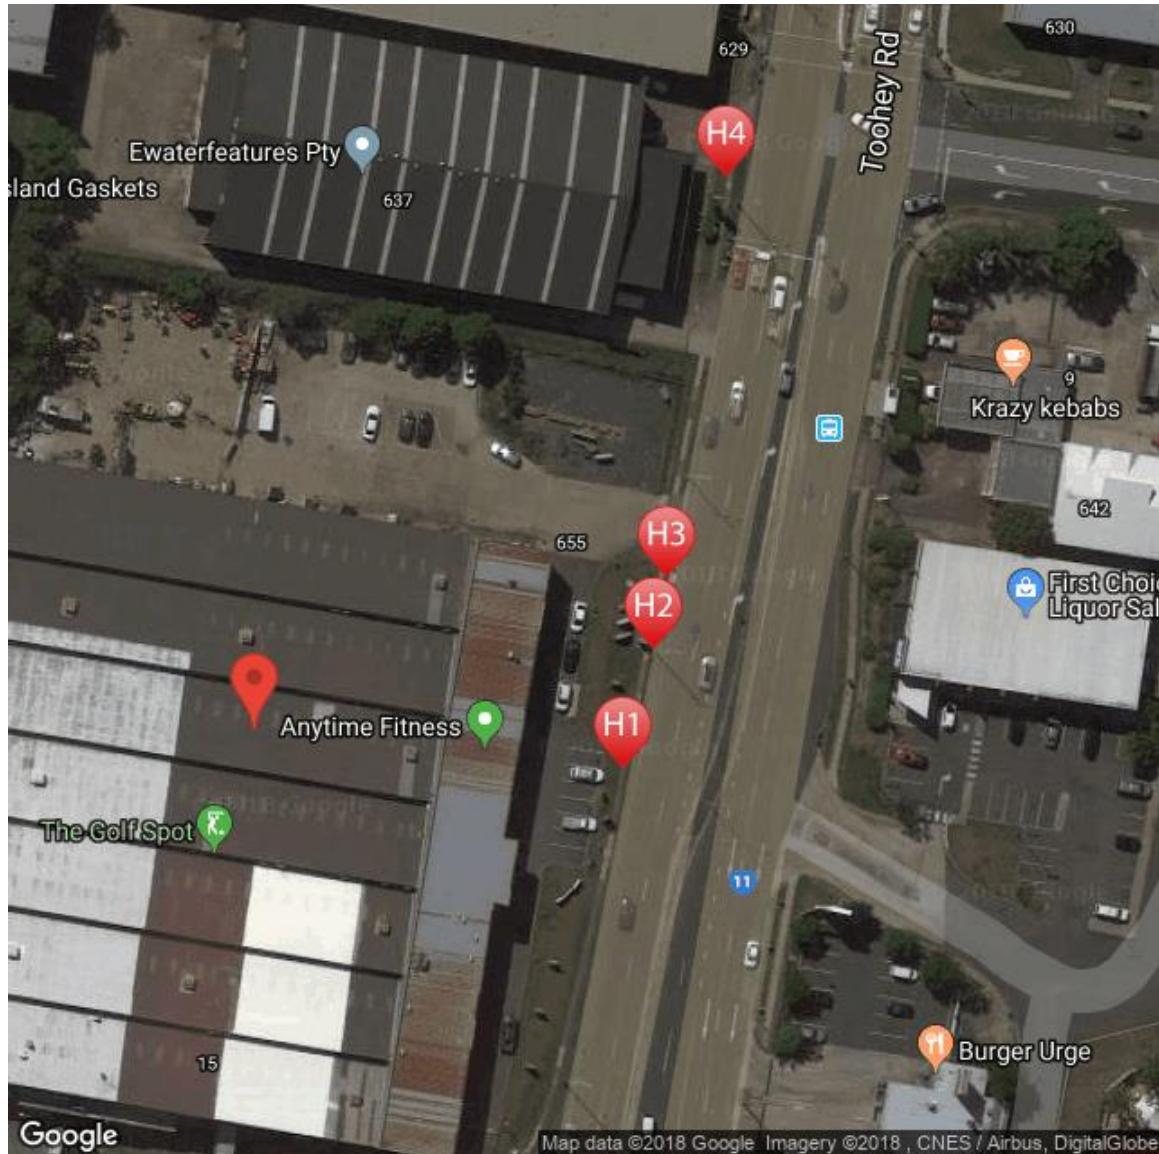
Test 1: Hydrant (H1) and 225MM CI water main performance test. Water was drawn, at the flow rates below, from both outlets of a standpipe attached to street spring hydrant H1, suction side of QUU pump. The pressure was recorded at the outlet of H1 to determine the hydrant performance. This test is used to determine if the hydrant meets the flow and pressure requirements of AS2419.1 (if applicable). The water main residual pressure was measured from a standpipe attached to spring hydrant H2.

Test 2: Hydrant (H4) performance test. Water was drawn, at the flow rates below, from both outlets of a standpipe attached to street spring hydrant H4, QUU Pump discharge. The water main residual pressure was measured from a standpipe attached to spring hydrant H3. This test is used to determine the performance of the street main to design an on-site hydrant main (if applicable).

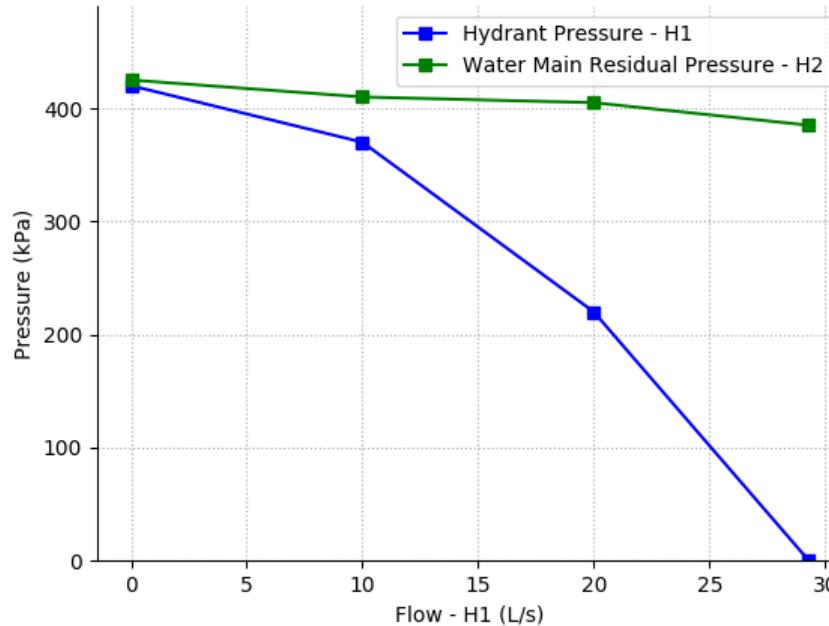
Test 1: Hydrant (H1) and 225MM CI water main performance test

Flow - H1 (L/s)	Hydrant Pressure - H1 (kPa)	Water Main Residual Pressure - H2 (kPa)
0	420	425
10	370	410
20	220	405
29.3	0	385

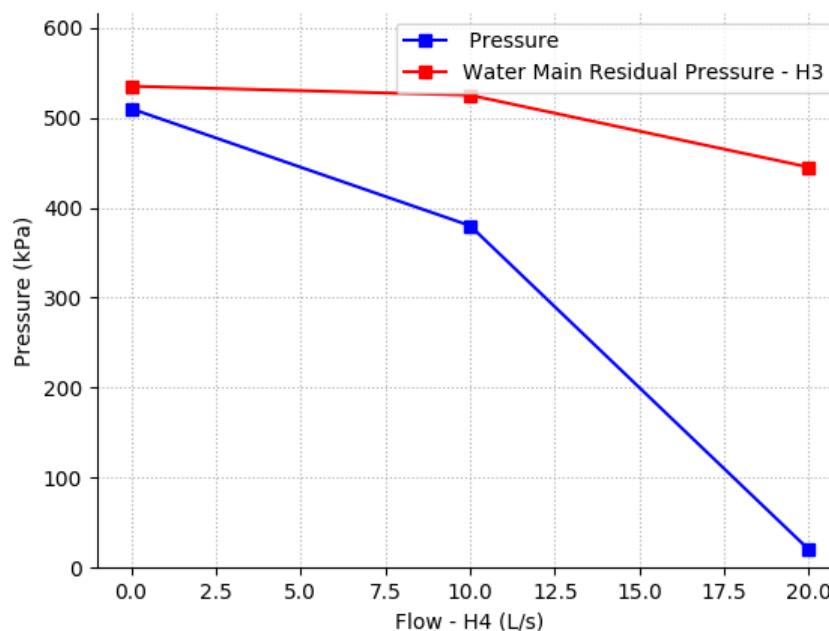
Test 2: Hydrant (H4) performance test

Flow - H4 (L/s)	Hydrant Pressure - H4 (kPa)	Water Main Residual Pressure - H3 (kPa)
0	510	535
10	380	525
20	20	445

Test 2 comments: The two isolation valves seen in image 1 between H2 and H3 are in the open position. The pump did not sound like it ramped up during test 2 (or 1).

Hydrant Condition: H1, H2 and H3 were in good condition with a powder coat exterior. H4 had a corroded cast iron exterior suggesting the hydrant performance would improve if it were replaced.

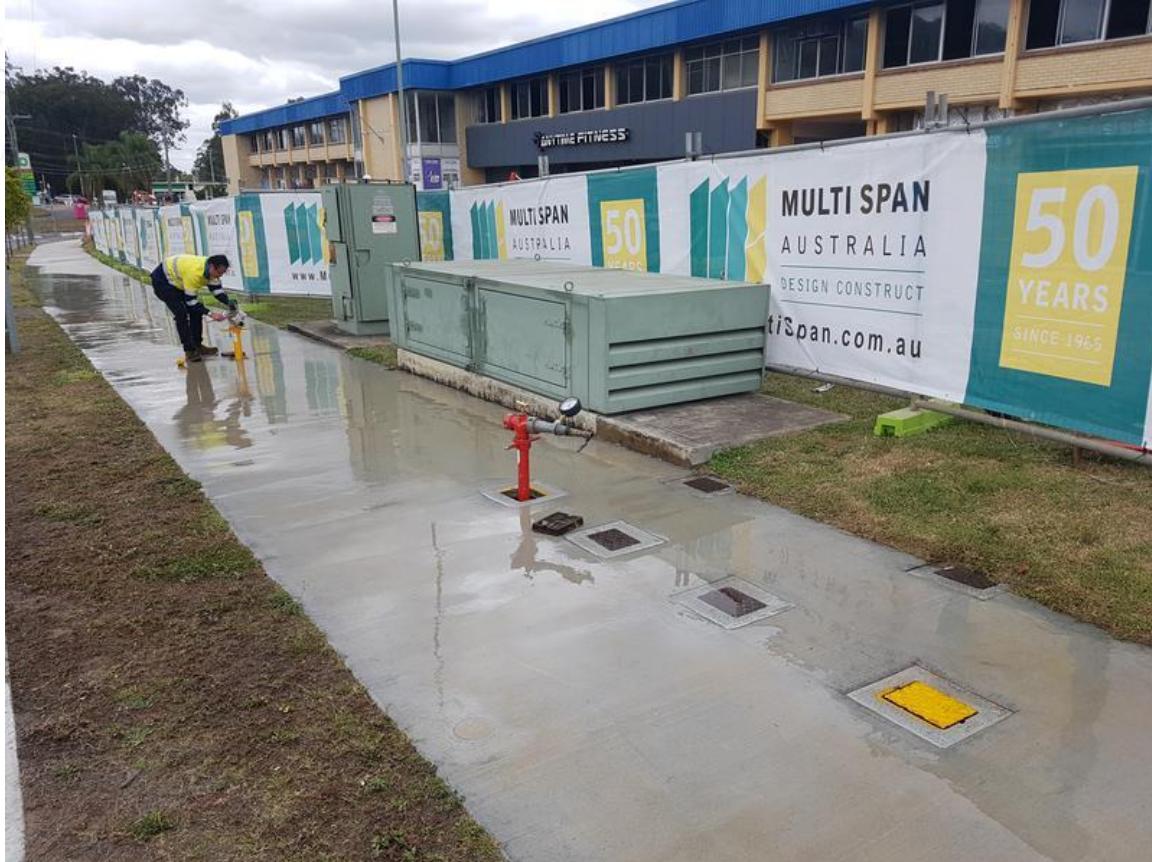
Image 1: H1 to the left, H2 in the center and H3 (without a standpipe) to the right. The QUU pump case can be seen.
